Savant AS-414BM, Auto Shut Off Valve for Water Leak

SAVANT ELECTRONICS INC.

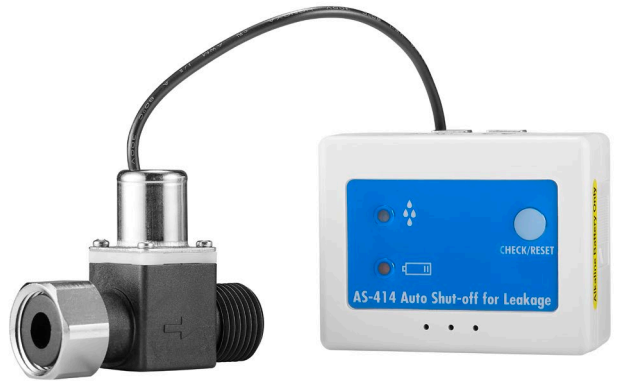
- ☐ Auto shut off water when water leak is detected
- ☐ 9V alkaline battery operated
- ☐ Auto shut off when battery power is low
- ☐ Easy installation
- ☐ Protection for water filter, water softener and home appliance.

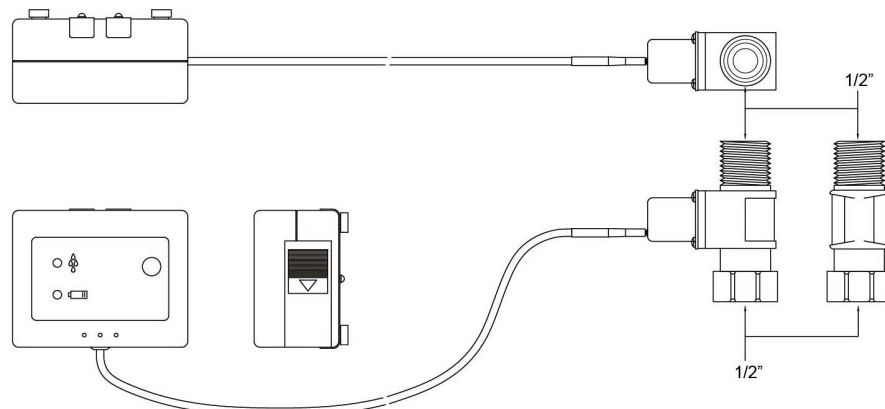
Mechanism :

Water leak detecting method : Control unit with detecting metal put on the floor near water filter

Keep pressing button for 4 seconds, the control unit activates solenoid valve to open the inlet tube of water treatment system, and generates a long beep sound.

The control unit shuts activate solenoid valve to shut off the inlet tube of the water treatment system to block water flow, and generates an acoustic signal, “beep-beep” , and blinks the blue light continuously to notify the water leak is detected. After the leakage problem is solved, keep pressing button for 4 seconds, the control unit activates solenoid valve to open the inlet tube of water treatment system again with a long beep sound.

When the battery power is low, the control unit shuts off the inlet tube of the water treatment system, blinks red light and generates an acoustic signal “beep” to notify that the battery needs to be replaced to keep water leak protection be functional.

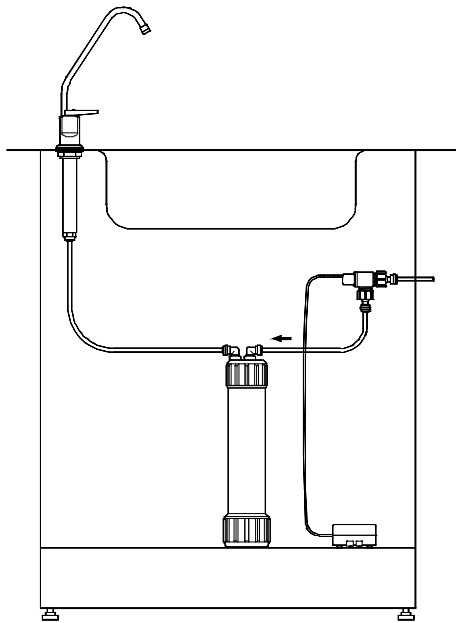
2.1 Installation :

Install the proper fitting with the solenoid valve. The thread of solenoid valve is 1/2" BSP male. Then connect the inlet tube of the water treatment system with the solenoid valve.
